# CNG buses fire safety: learnings from recent accidents in France and Germany

**Lionel PERRETTE**

**Helmut K. Wiedemann**

## THE SAARBRÜCKEN ACCIDENT: DESCRIPTION AND LEARNING

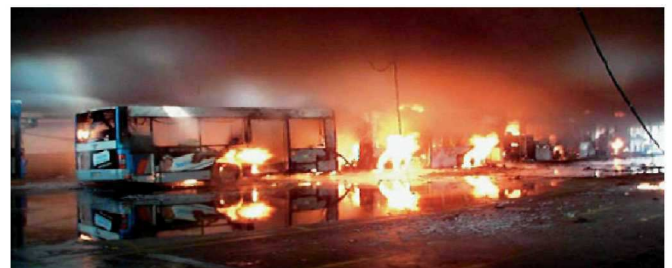
The fire propagated from the back of the first bus to another articulated bus parked in a row at 1.5 meters behind. At 3:09 pm the fire is well developed inside the depot and violent explosions occur. These explosions are caused by the release through actuated PRDs, mixing and later combustion of natural gas inside the depot. Both buses have been burnt out whereas the other ones have been extracted from the depot before they caught fire. The first bus burnt from the back to the front. The second bus burnt the opposite way.

Figure 3: View of the fire once it was under control (from [6])

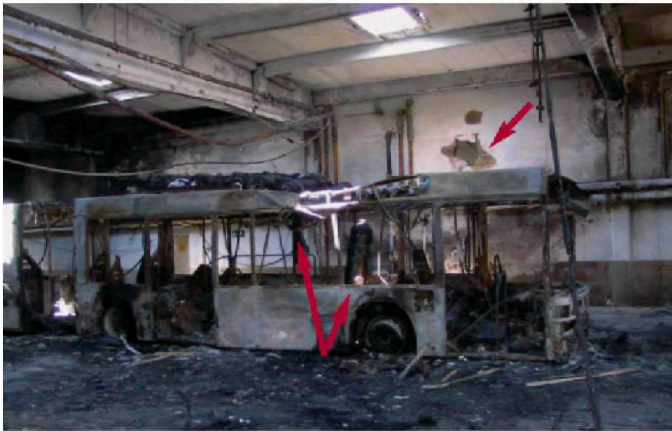
It went a different way for one of the tanks mounted on the second bus whereas the fire was “under control”. The tank burst about 15 minutes after the fire started. A large tank fragment was propelled in the tank axial direction. It broke through a nearby wall (hole at 3 meters from ground level) flew through the air and damaged another wall located 25 meters further and ended up its journey on the roof of a bus parked in a nearby depot. The tank that burst was the first in the row

when looking at the bus from the front (tank n°1). The fire was put out at 4:30 pm. Nobody was injured.

Figure 4: Destroyed bus with red arrows pointing (from right to left), tank n°3, hanging tank n°2 and hole through which tank n°1 flew (from [6])

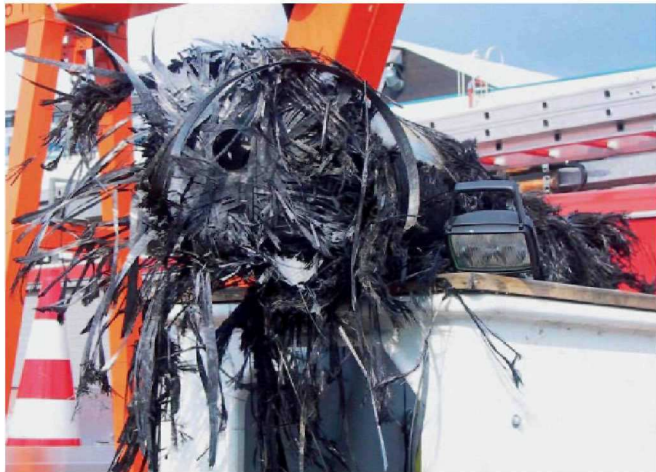
Figure 5: Remains of tank n°1 after it landed (from [6])

Investigation lead to the following explanations. Tank n°1 burst for two concomitant reasons:

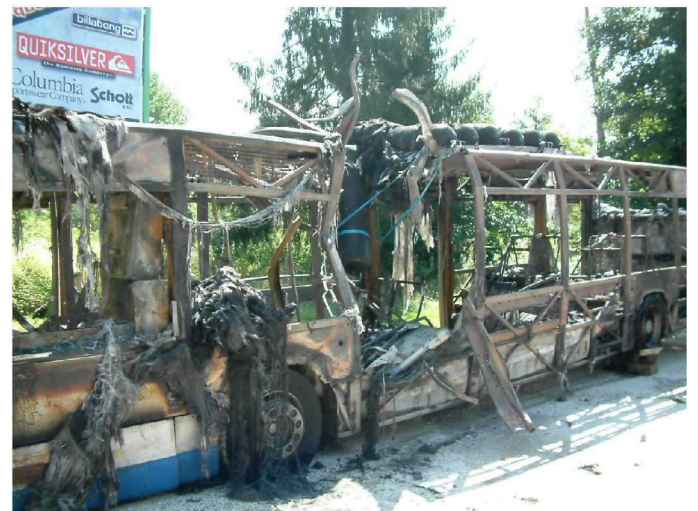
Firemen stood at a safe distance in front of the bus and tried to cool down the tank system with water spray. 10 minutes later at 6:51 am, the front cylinder exploded causing slight and directional damages to the environment within a distance of 100 m. Damages were caused by tank debris (tank n°1 damaged the roof of an adjacent house after a 30 m fly) and overpressure (poster frame unhooked and damaged sliding shutters 60 m away from explosion). As it burst, tank n°1 also propelled the adjacent tank to the other side of the road (10 m away). The tank n°1 ruptured in large pieces whereas carbon fiber could be found as far as 150 m away. Tank n°1 valve and associated fuse have not been found after the accident. Bursting noise could be heard at a 5 km distance. Firemen did not report any noticeable fireball though they felt a transient heat. Nobody was injured.

Figure 9: Side view of the bus with tank n°3 hanging (Courtesy SDIS 25)

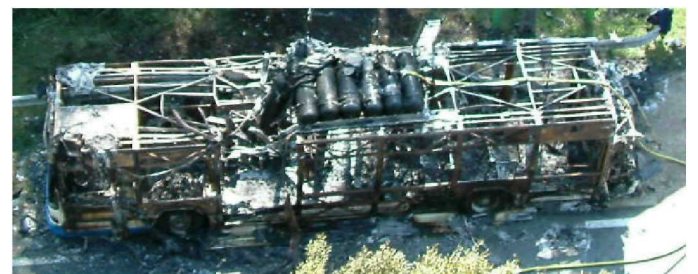
Figure 10: Top view of the bus (Courtesy SDIS 25)

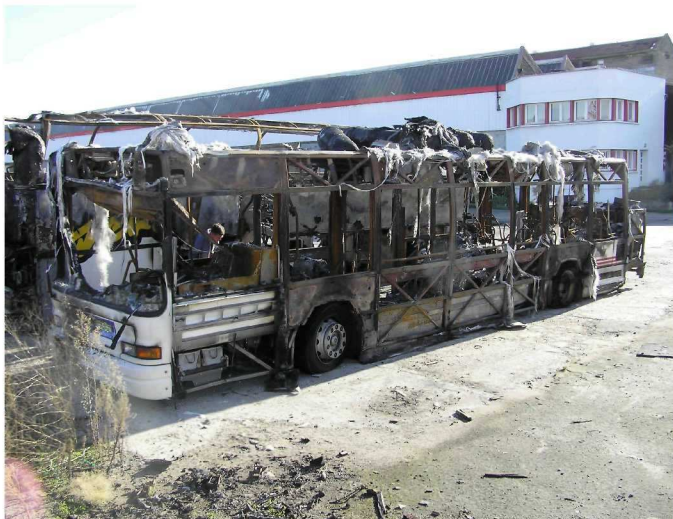
The bus concerned by this later accident is exactly of the same type as the one we have just presented in the Montbeliard case though accidental circumstances are different. On the 8th of November 2005, at 6:50 pm, vandals deliberately threw a Molotov cocktail inside the passenger compartment at the rear of the bus. At that time the remaining pressure inside the storage system was estimated between 100 and 70 bar. Witnesses reported that the fire propagated rapidly and soon broke through the roof panel mounted 20 cm ahead of tank n°1. Tank n°1 burst within 10 minutes after fire broke out and before the fire brigade arrived. Horizontal jet flames were also witnessed meaning that PRD release deviators did also collapsed. Finally, firemen reported various moderate deflagrations. Damages were limited and nobody was injured as a result of this accident.

Figure 13: View of the bus after the fire (courtesy bus manufacturer)

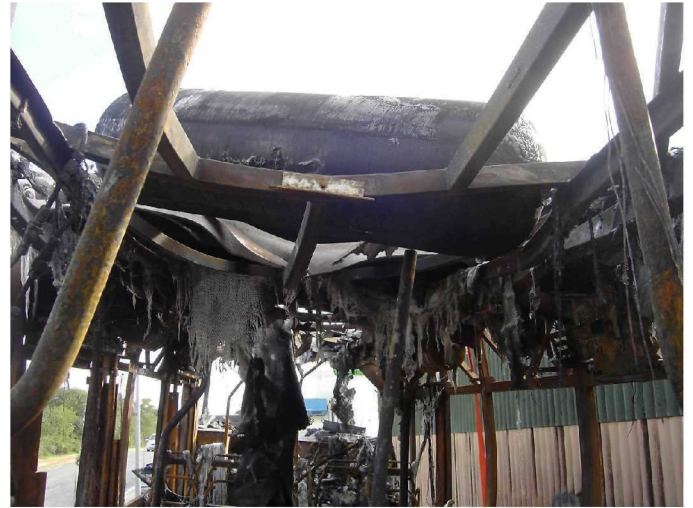
Figure 14: View of tank n°1 that exploded (one half)

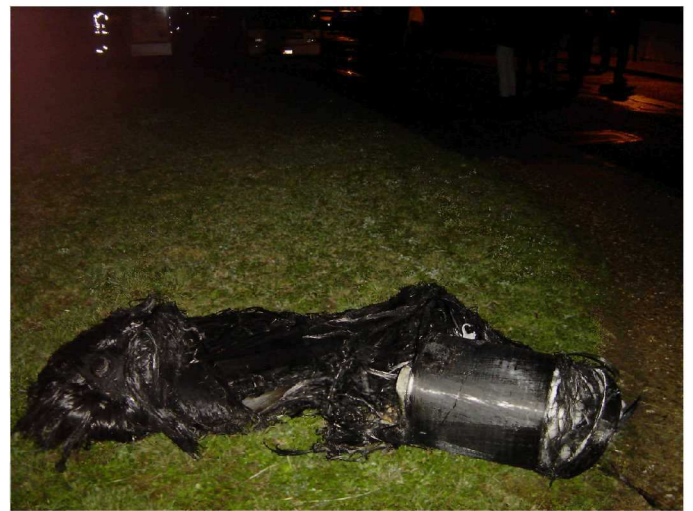
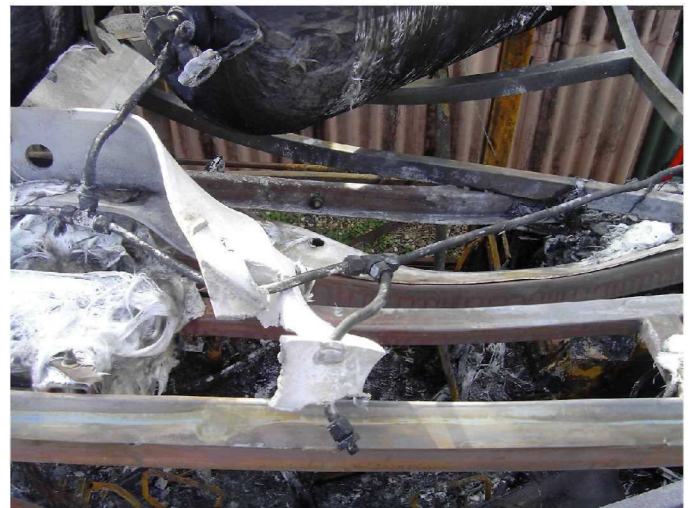
Figure 15: View of the bus from the inside (tank n°2)

Figure 16: View of the bus from the inside (tank n°2)
